LAKE MOKOMA DAM

NDS ID NO. PA-359

PHASE I INSPECTION REPORT
NATIONAL DAM INSPECTION PROGRAM

L. ROBERT KIMBALL & ASSOCIATES
CONSULTING ENGINEERS & ARCHITECTS
EBENSBURG, PENNSYLVANIA
15931

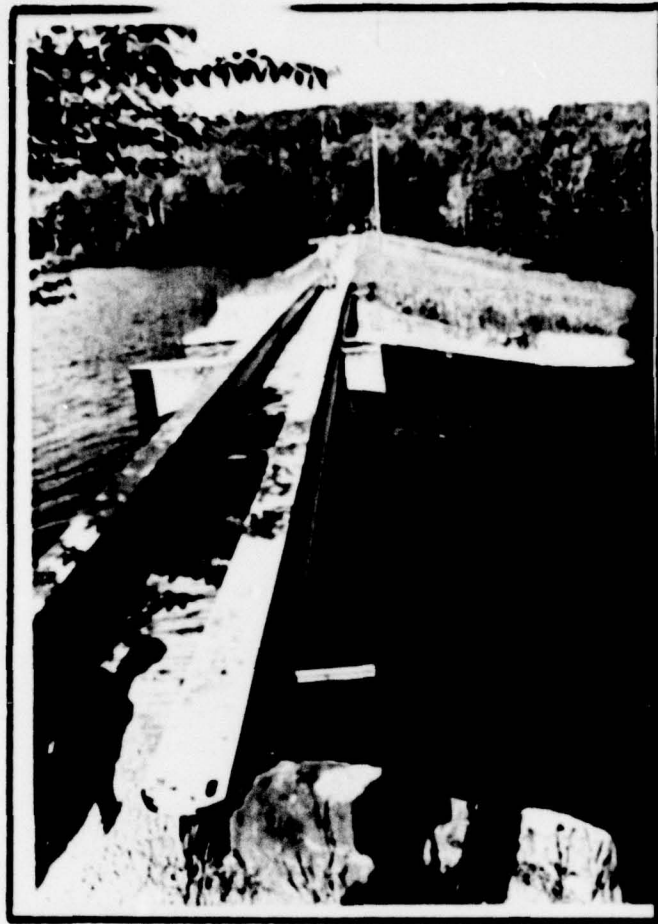
Overview of dam and spillway from
right abutment.

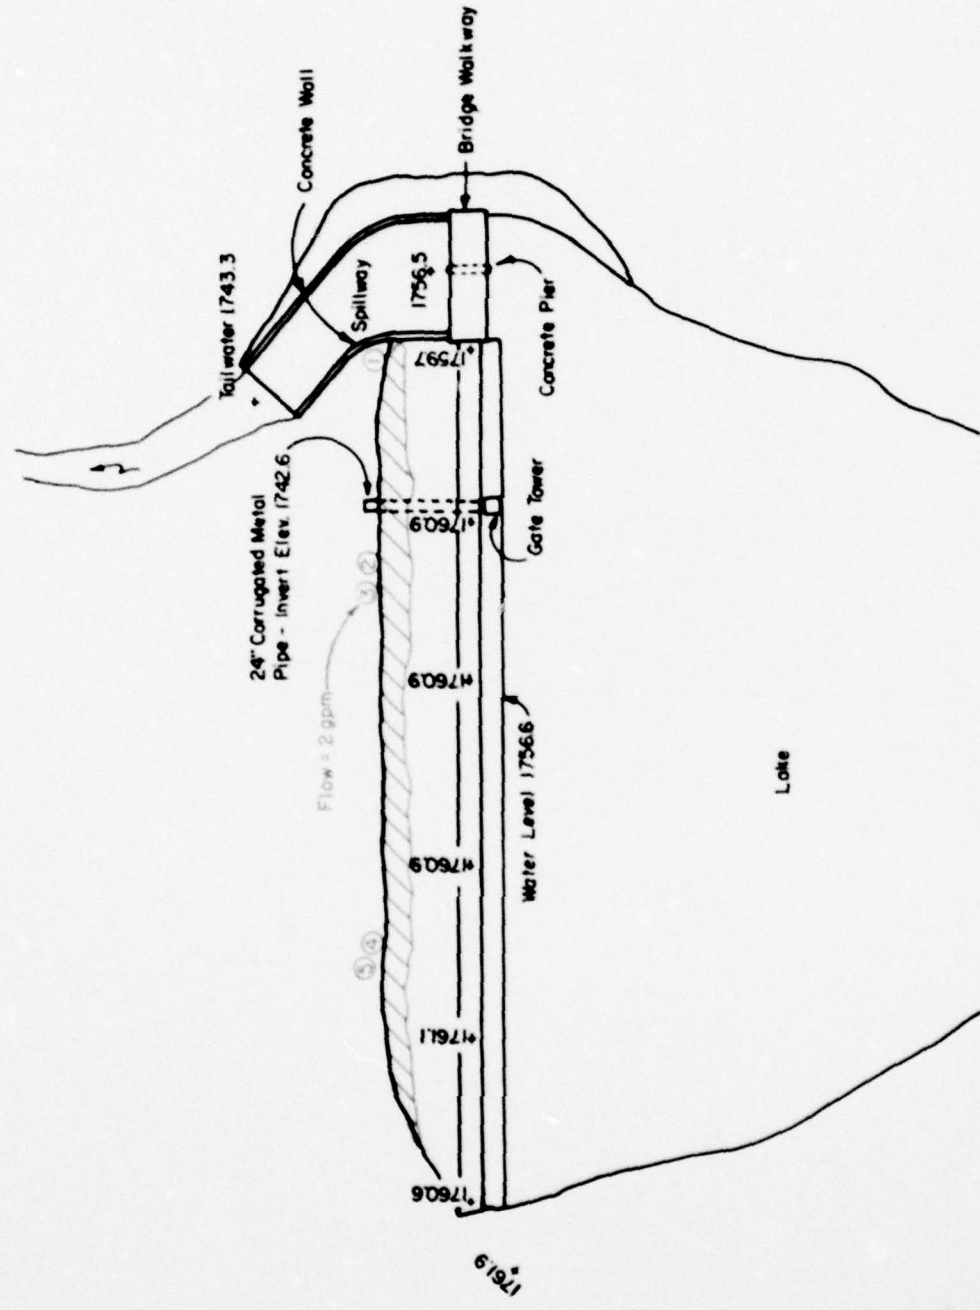
LAKE MOKOMA DAM Scale: 1" = 100'

b. Dam. The dam appears to be in fair condition. The crest of the dam is 12 feet wide and has a recently placed gravel foot path over the top. The upstream slope is 2H:1V and covered with recently placed heavy stone riprap. The downstream slope is 3H:1V and partially covered with high grasses. Seepage is exiting on the downstream slope at a very consistent elevation (1750 to 1752) along the entire downstream slope. High grasses easily mark the location of this seepage zone. At the toe of the dam, five wooden flumes have been constructed to collect the seepage. Maximum seepage measured during the inspection was at weir number three which was measured at approximately 2 gallons per minute. The other four measuring points indicated less than 1 gallon per minute. However, it is questionable whether these flumes intercept all of the seepage (See page A-12).

①, ② etc. Indicate Weir Points with Flow < 1 gpm Unless Otherwise Noted

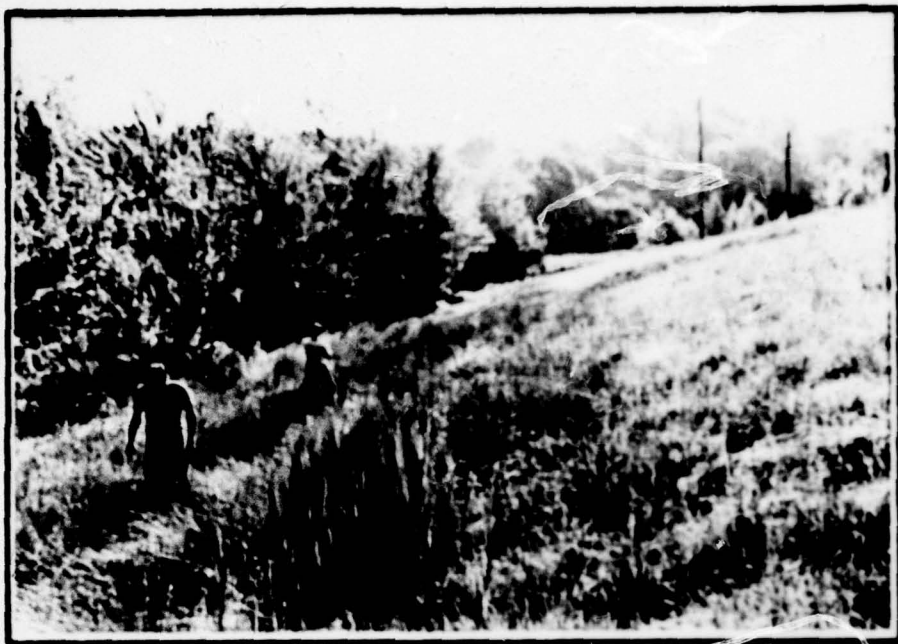
a. Visual Observations. The high level of seepage exiting on the downstream slope is of concern. This seepage is approximately 4 to 6 feet above the downstream toe of the dam and approximately 4 feet below normal pool. The downstream material in the embankment consists of a sand. This material with a high head is very susceptible to piping. In addition, deterioration of the timber cribbing can create voids and subsidence areas in the crest of the dam. The stability of the structure during high head conditions is questionable.

Downstream slope and wet area where high grass is present.

5. Because of the high level of seepage and the potential for piping to develop, a stability analysis should be conducted of the structure. Piezometers should be installed to monitor the phreatic surface.

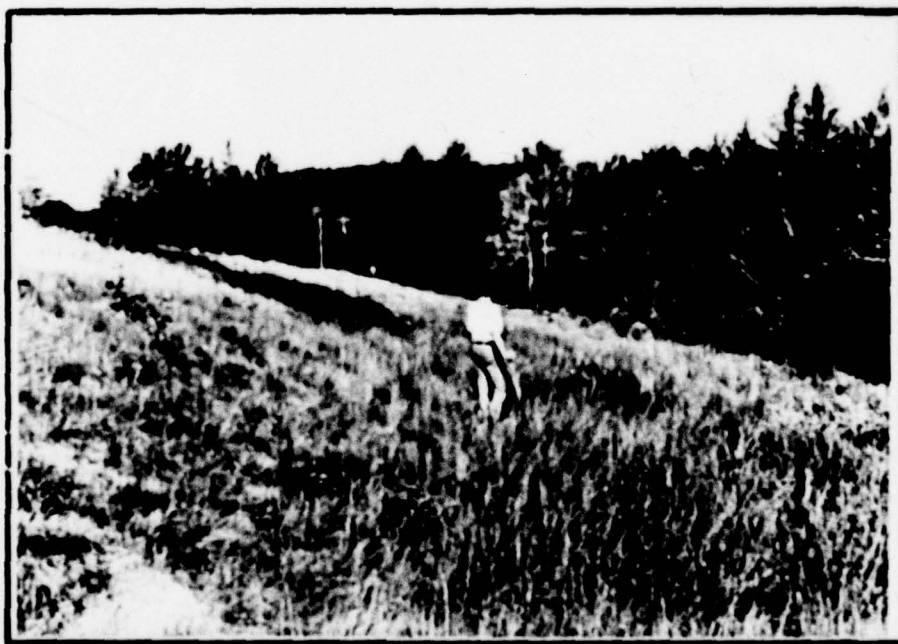
Downstream slope and wet area where man is standing.

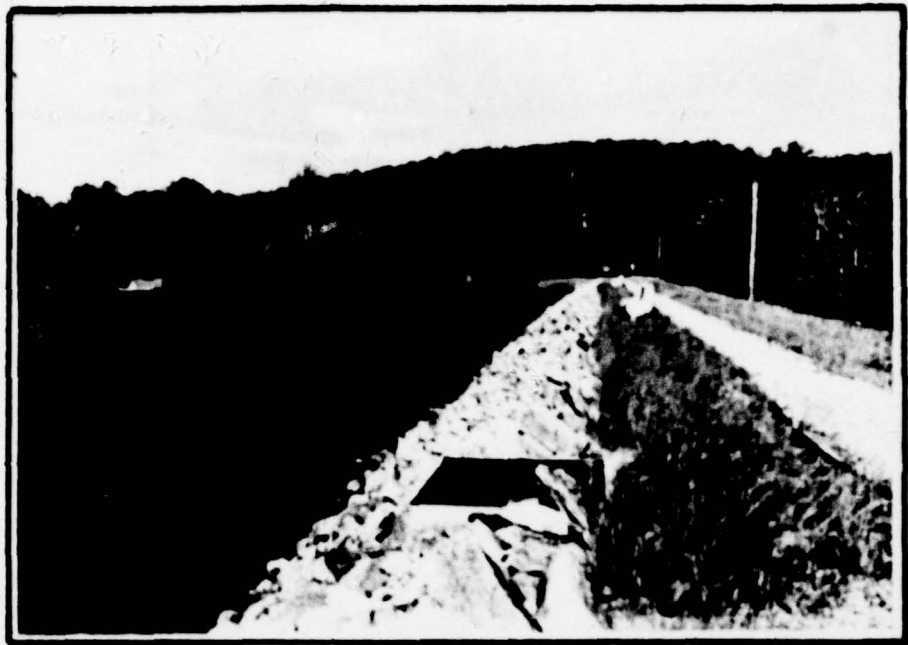
Upstream slope - valve box in foreground.

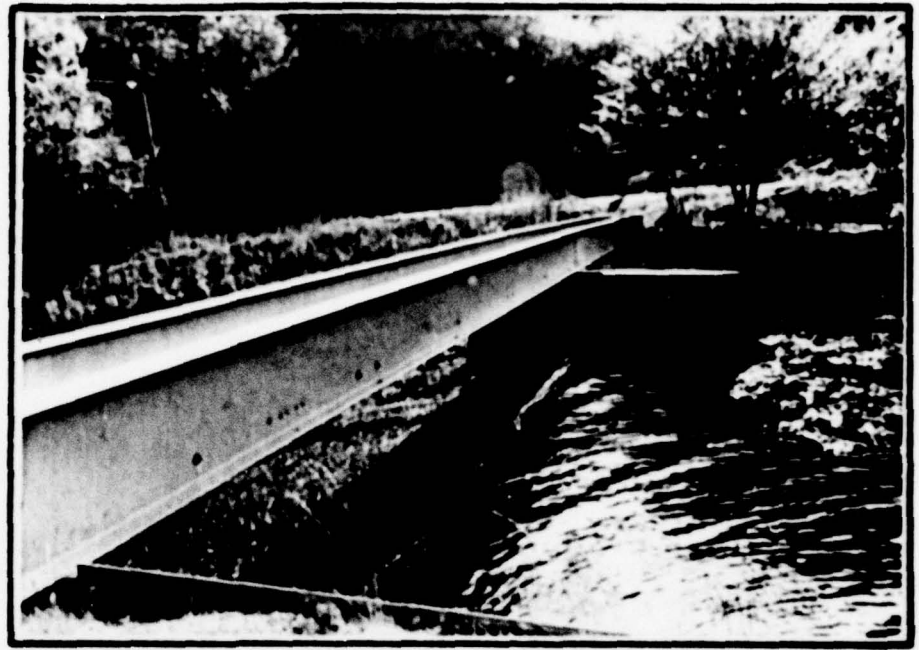
c. Visual Observations. The spillway and spillway discharge channel appeared to be in good condition. The concrete on the spillway weir and spillway walls have recently been repaired. During flood flows, the spillway may become partially blocked because of the small opening and pier in the middle of the spillway.

Spillway weir and bridge.

3. Repairs should be made to the spillway concrete and masonry on a regular basis.
